CITY OF HAMILTON

**Rennie Street Landfill
Remedial Works**

**Dillon Consulting
Limited**

**00-7447
August 2000**

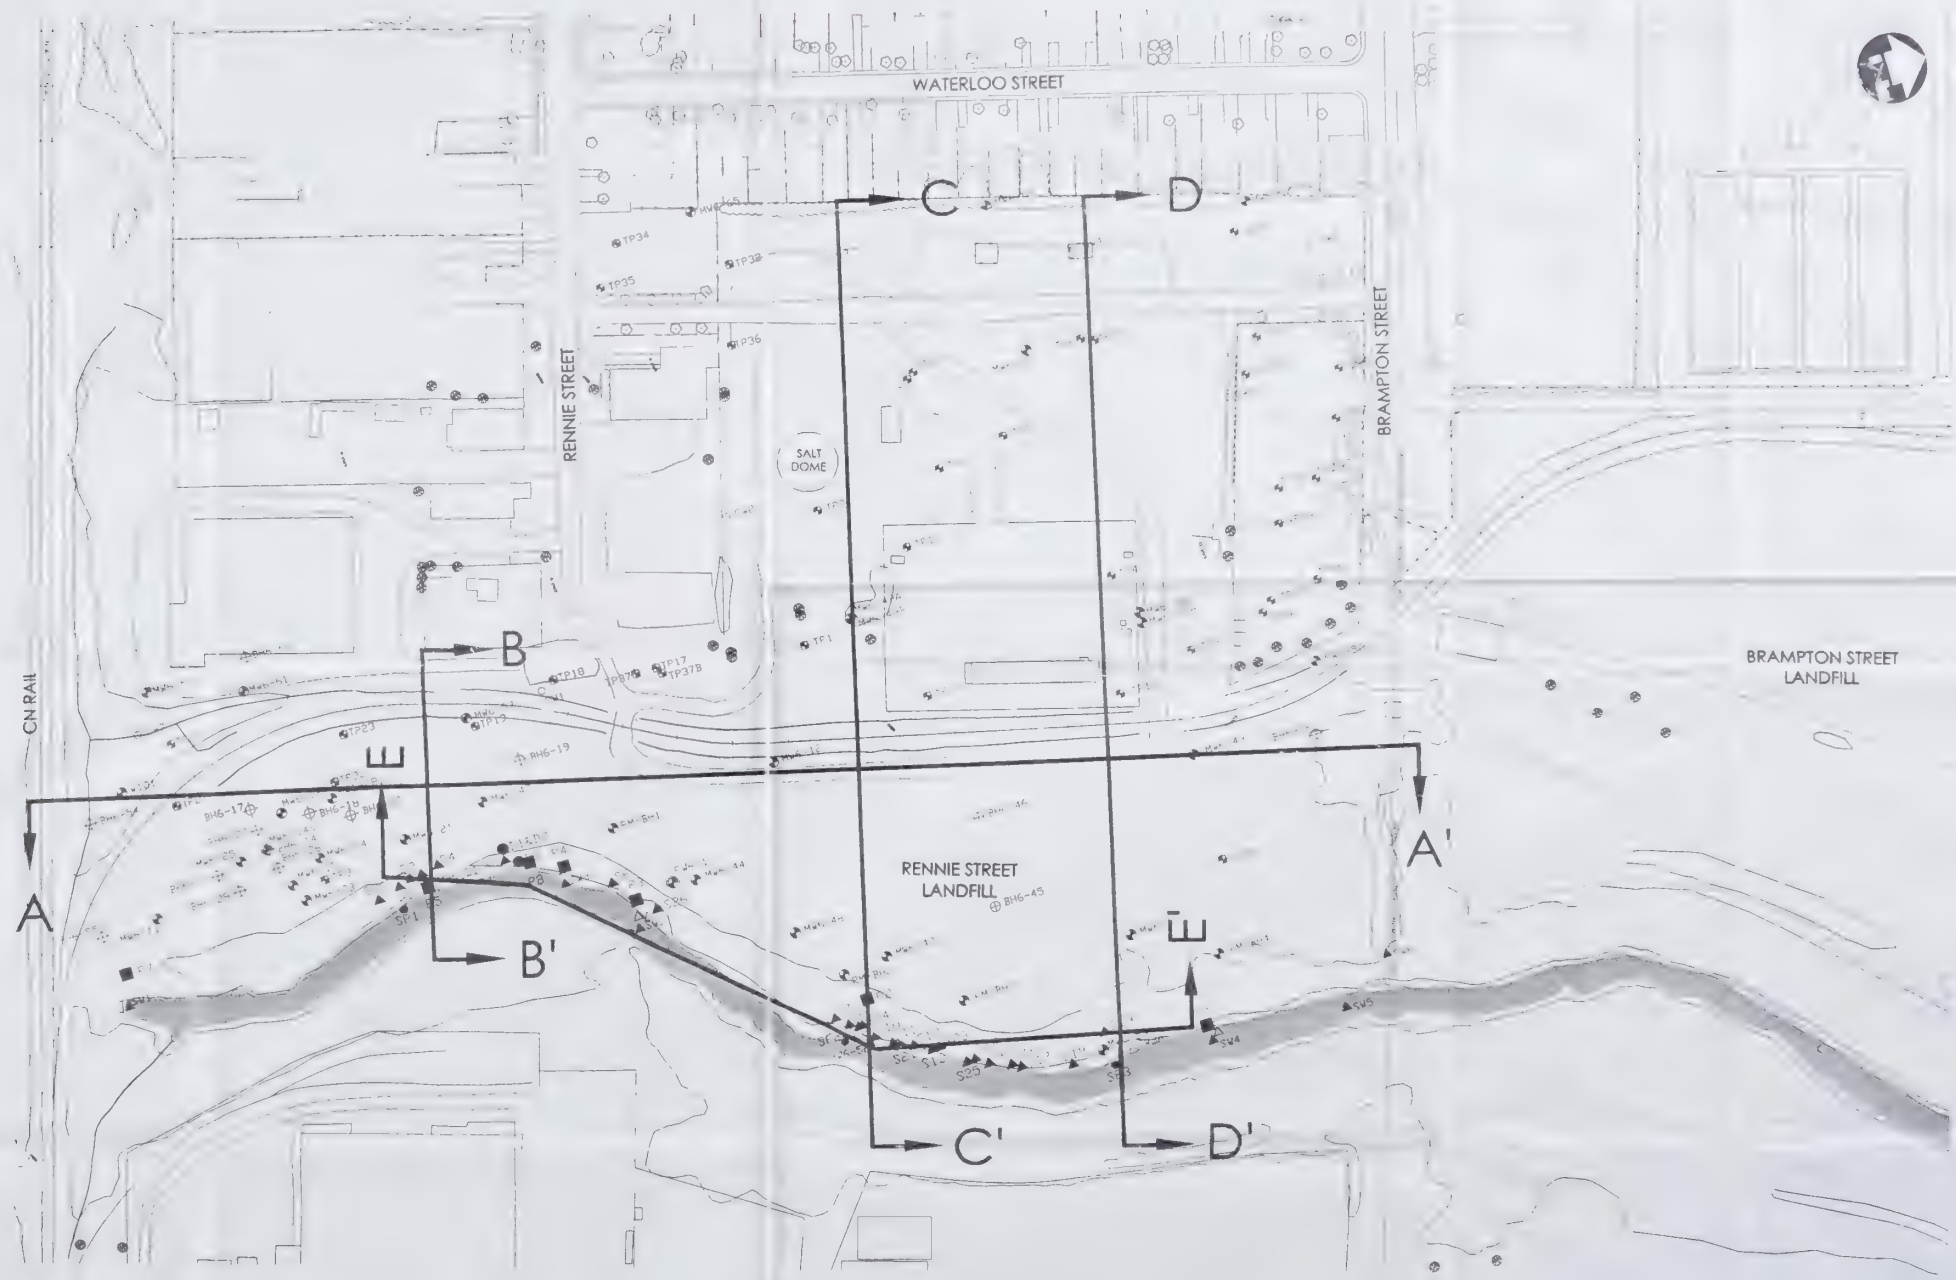
DATE AUGUST 2000	SITE PLAN	PROJECT NO. 00-7447
	FORMER RENNIE STREET LANDFILL INVESTIGATION	FIGURE NO. 2

The locations of these test pits (TP1 to TP38, inclusive) are shown on Figure 2 (back pocket). Test pit logs describing the subsurface conditions encountered are included in Appendix A

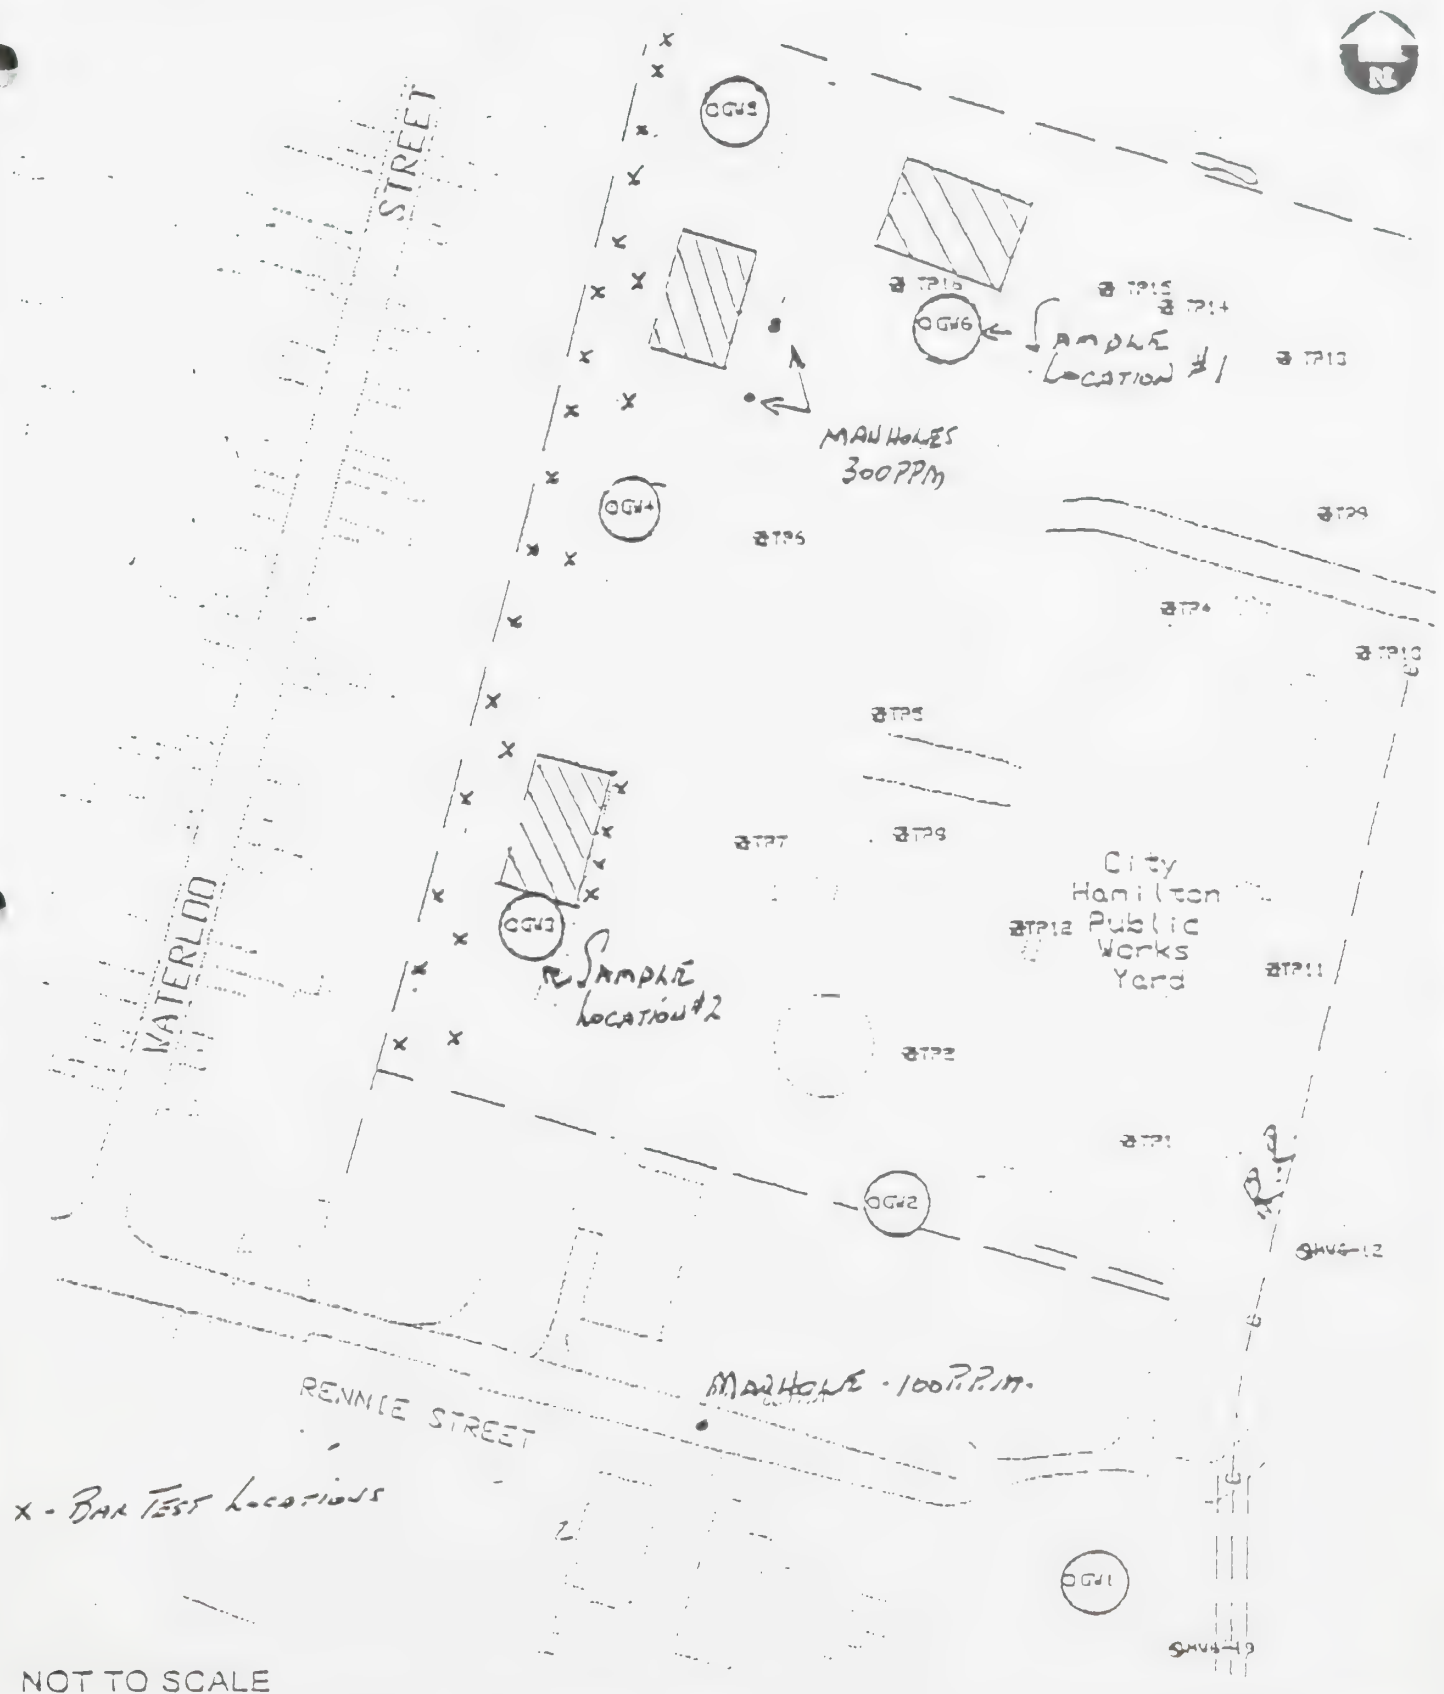
1

Following are the sketch maps identifying the bar test locations and sample collection points.

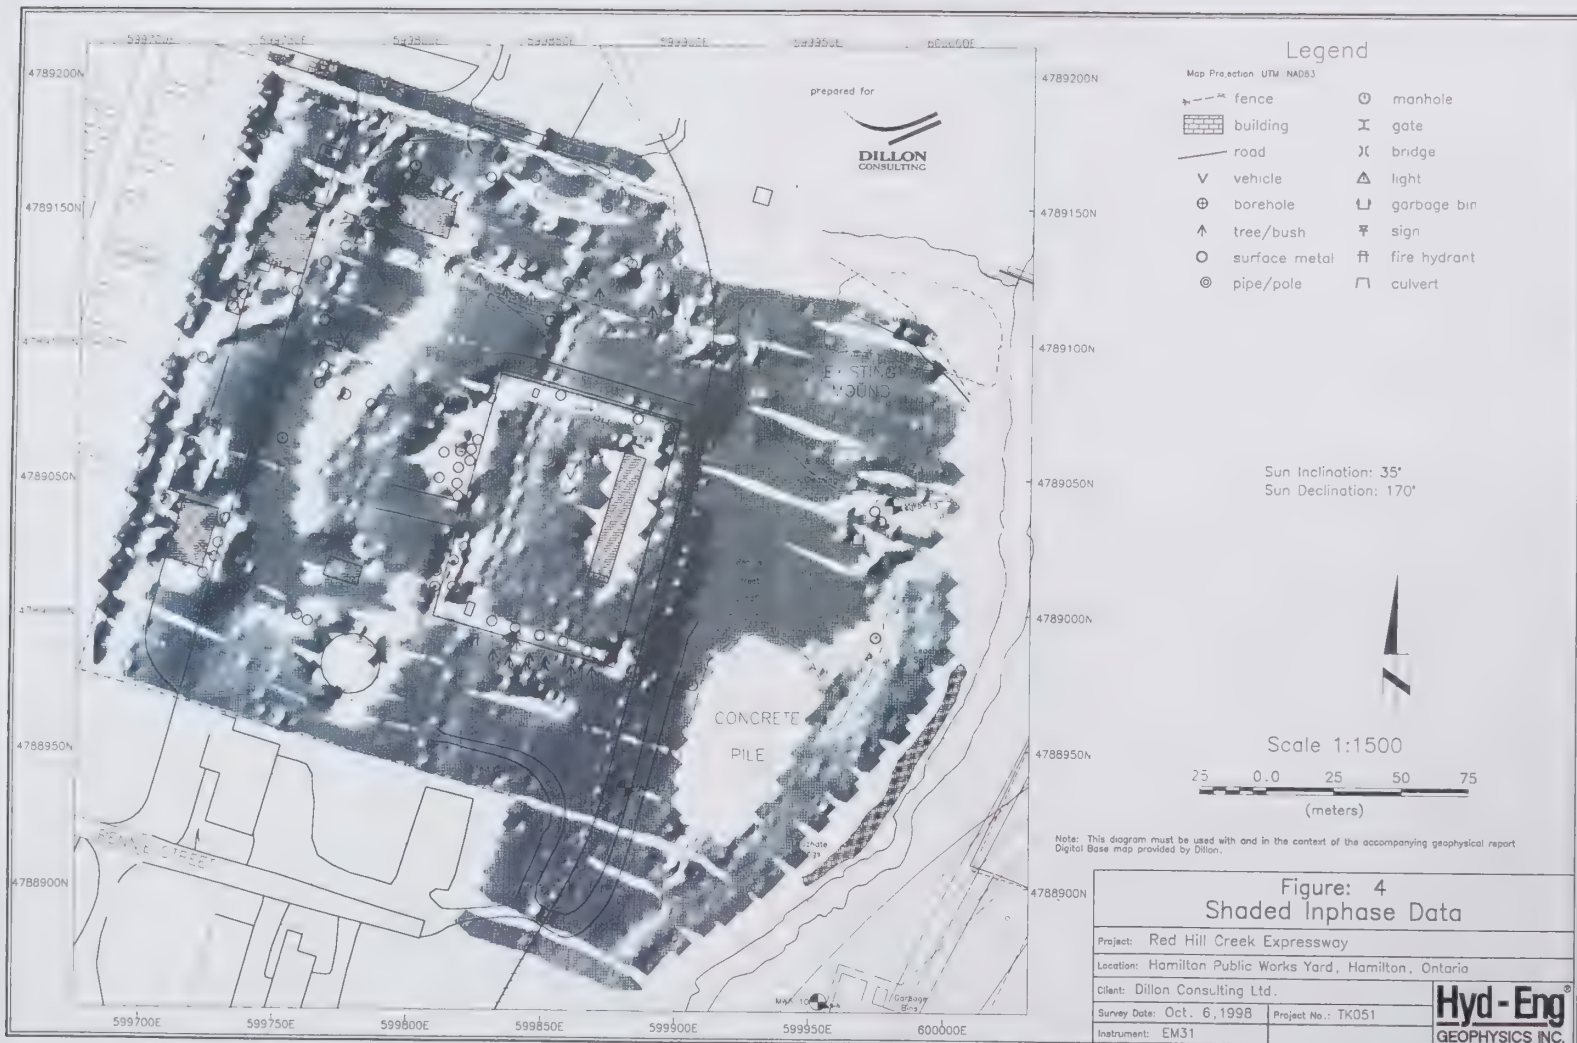
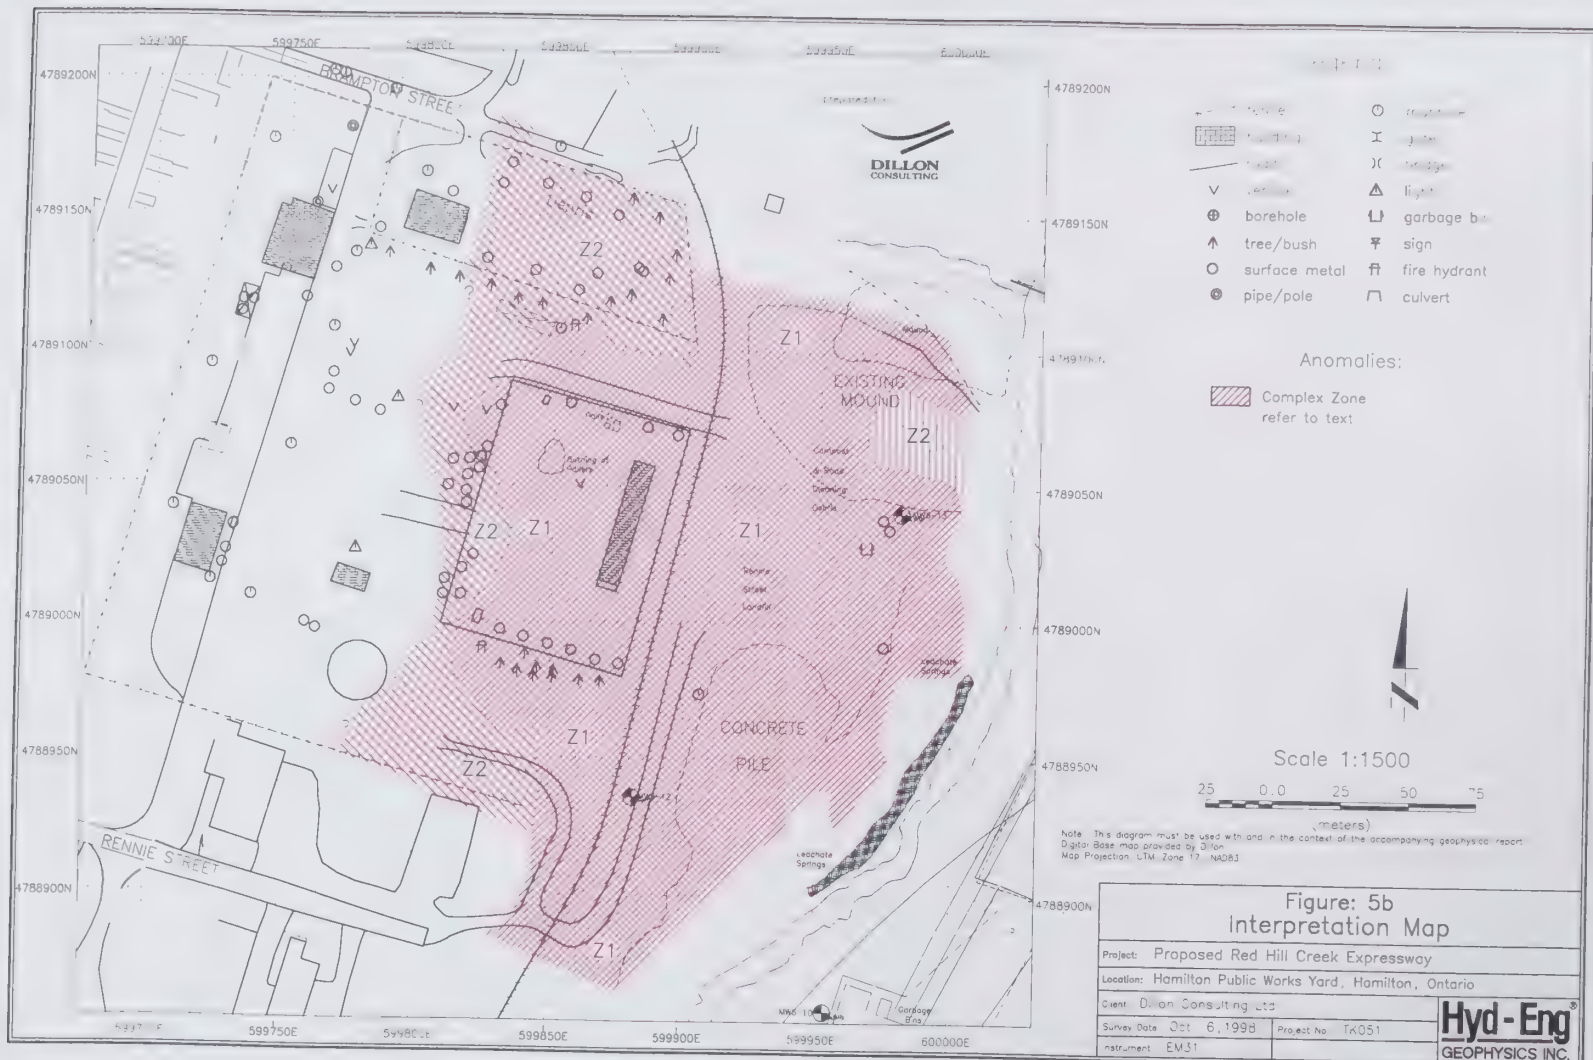
**A report on an
EM31 Survey,
conducted about the southern portion of the
Hamilton Works Yard,
Hamilton, Ontario**

boundary on Figure 5b correlates well with observed test pit information and general trends observed in the geophysical data.

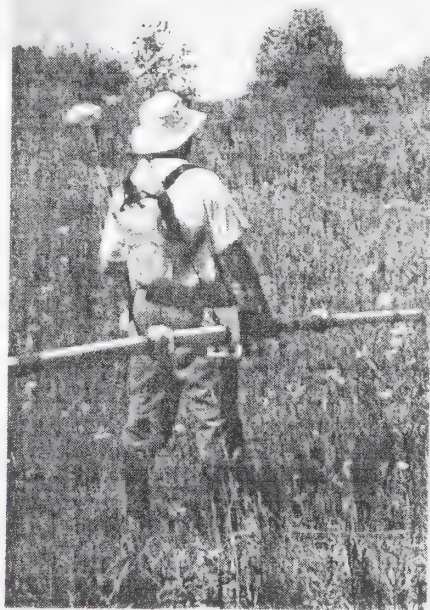
Figure 1: EM31 with GPS backpack

secondary EM field (produced by encompassing materials). The instrument then converts the EM field properties into quadrature (apparent conductivity) measurements of the subsurface in units of milliSiemens per metre (mS/m) and inphase measurements in parts per thousand (ppt). The value for the bulk apparent conductivity of the ground

represents a roughly hemispherical volume of radius 5 to 6 metres centred at the operator. The inphase response is sensitive to metal and relatively insensitive to changes in the apparent conductivity of the ground. However, extremely high ground conductivity will affect the inphase values. The quadrature response is somewhat affected by metal.

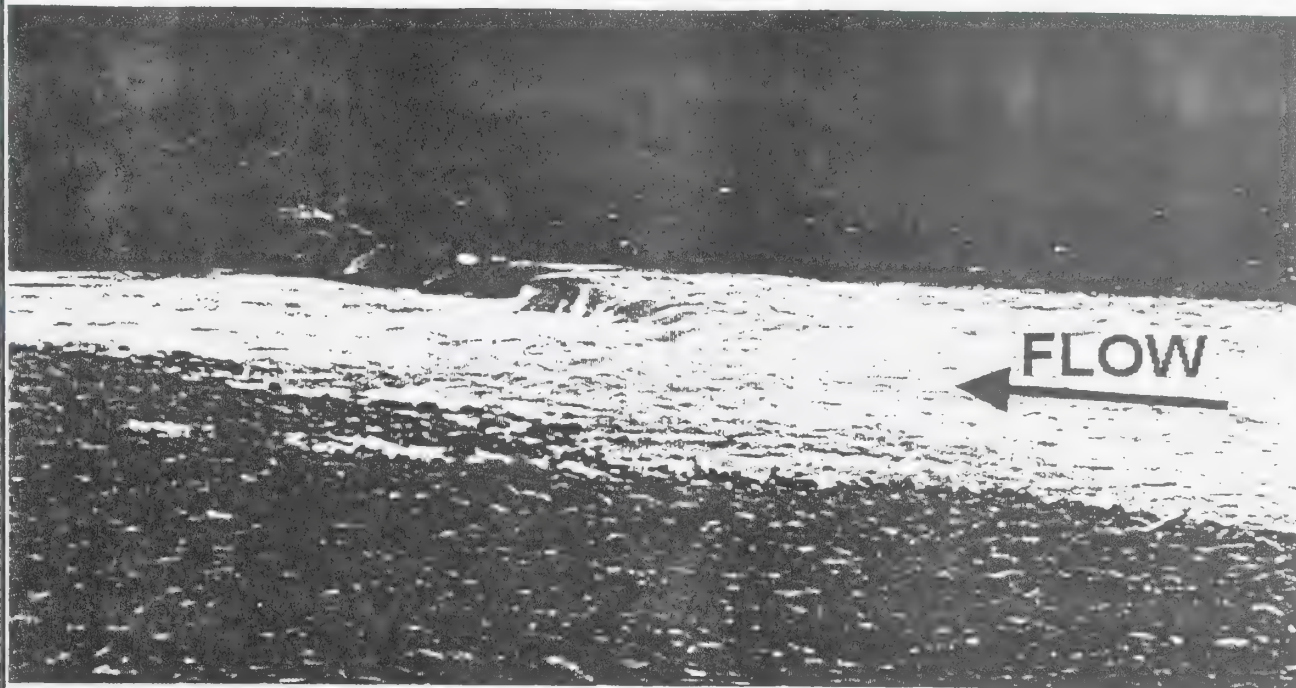
ROCK VEIN

Purpose:	Reduce / offset erosion on outside of bends
Placement:	Outside of bends, 1/4 channel width down stream of tangent to mean flow direction
Erosion Rates:	Monitored erosion rates <0.01m/year - typically immeasurable
Physical Method:	Reduction of near bank shear stress by local reversal in water surface profile gradient and momentum transfer to central portion of channel
Vegetative control:	Placement of sod mats and/or shrubs on outside of bank. Preferably inhibitory species to minimize pedestrian or grazing traffic.
Fish Habitat:	Quiescent water up-stream of structure with a high variability in flows (low and high flow) over the structure. Pool depths down-stream range between 2-4 bankfull depths.
<i>Reynolds Number Range</i>	$Re = 50$ through 2000+
<i>Froude Number Range</i>	Sub-critical through super critical flow

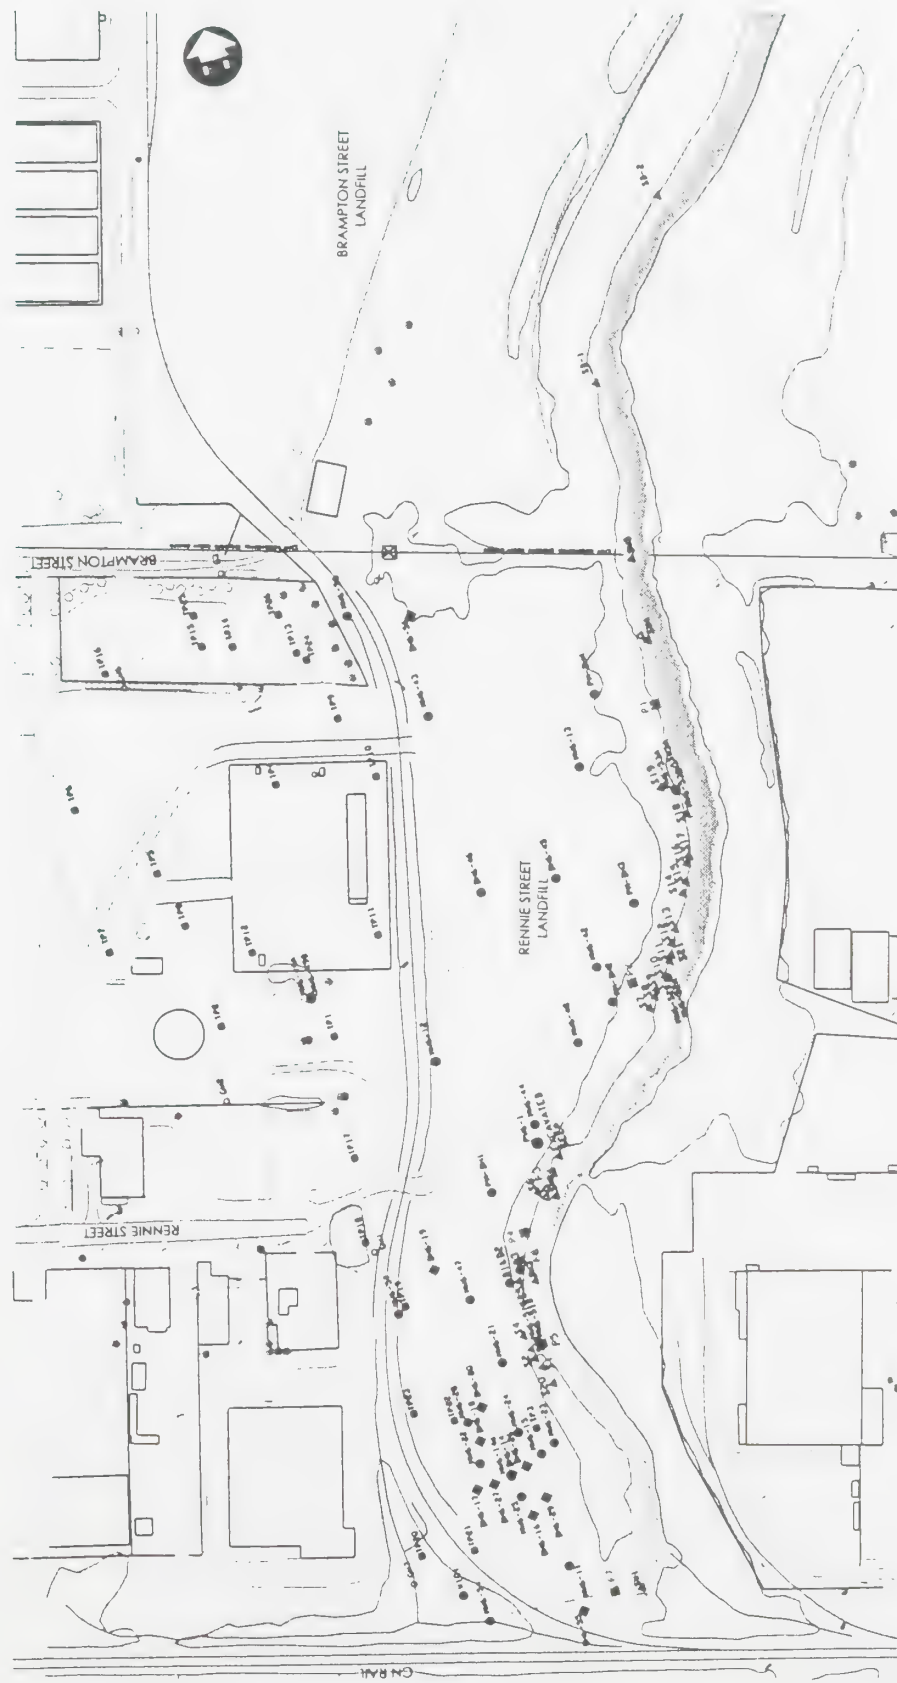
SITE PLAN

- Leachate is generated in landfills through the mixing of rainwater, snowmelt and groundwater that flows into the landfill with liquid from the decomposing waste.
- The leachate is coming out of the landfills at locations along the west bank of Red Hill Creek. We call these localized flows seeps.
- The leachate has unacceptable concentrations of PCBs, petroleum hydrocarbons, ammonia and chlorides.
- The oily leachate has contaminated the soil on the west bank of Red Hill Creek.
- Erosion is causing oily seeps to be exposed at the Brampton Street Landfill.
- In the long-term, erosion and scouring of the bank is expected to eventually cause waste and contaminated soil to enter the creek.
- The Rennie Street Landfill is generating landfill gas which should be vented to prevent movement off-site in the future.
